Fire Resistance Test Report

Report: BMT/FEI/F14107

A fire resistance test performed on a non load bearing 60 minute ceiling membrane fitted with a loft hatch
Test conducted to BS EN 1364-2: 1999 to the temperature and pressure conditions outlined in BS EN 1363-1: 2012

Test date: 11th September 2014

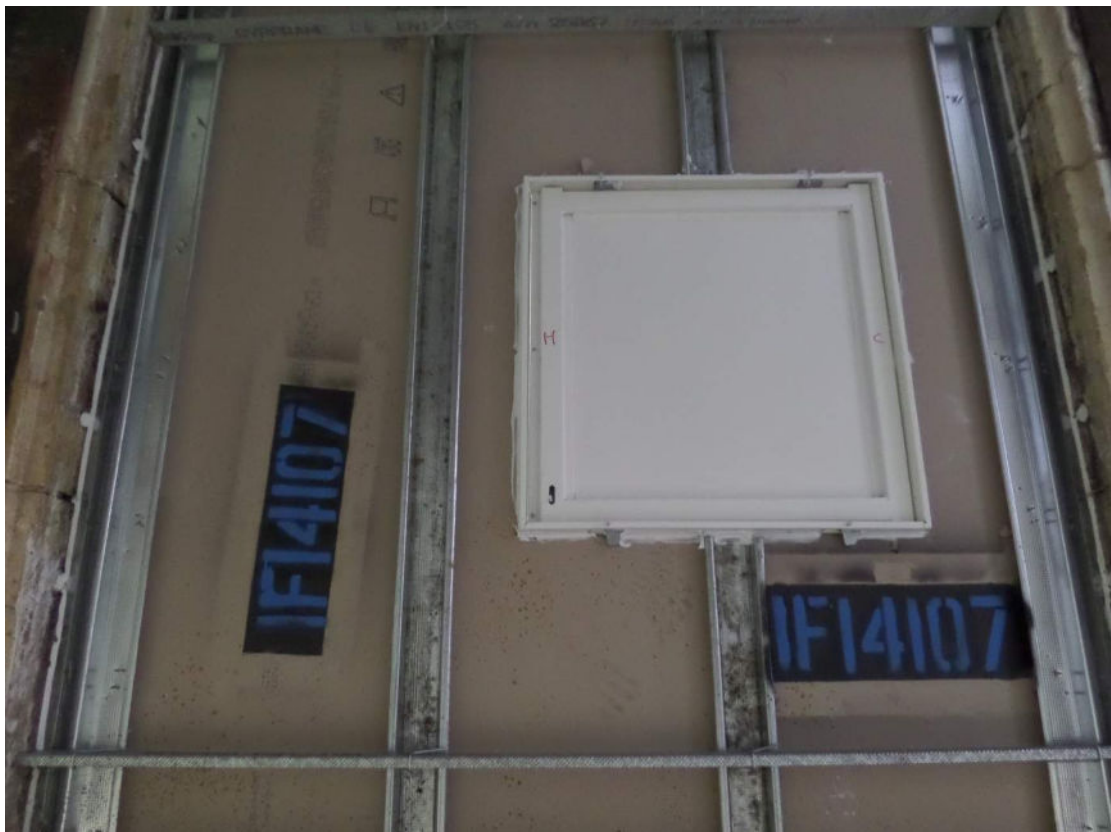
Unexposed face prior to testing

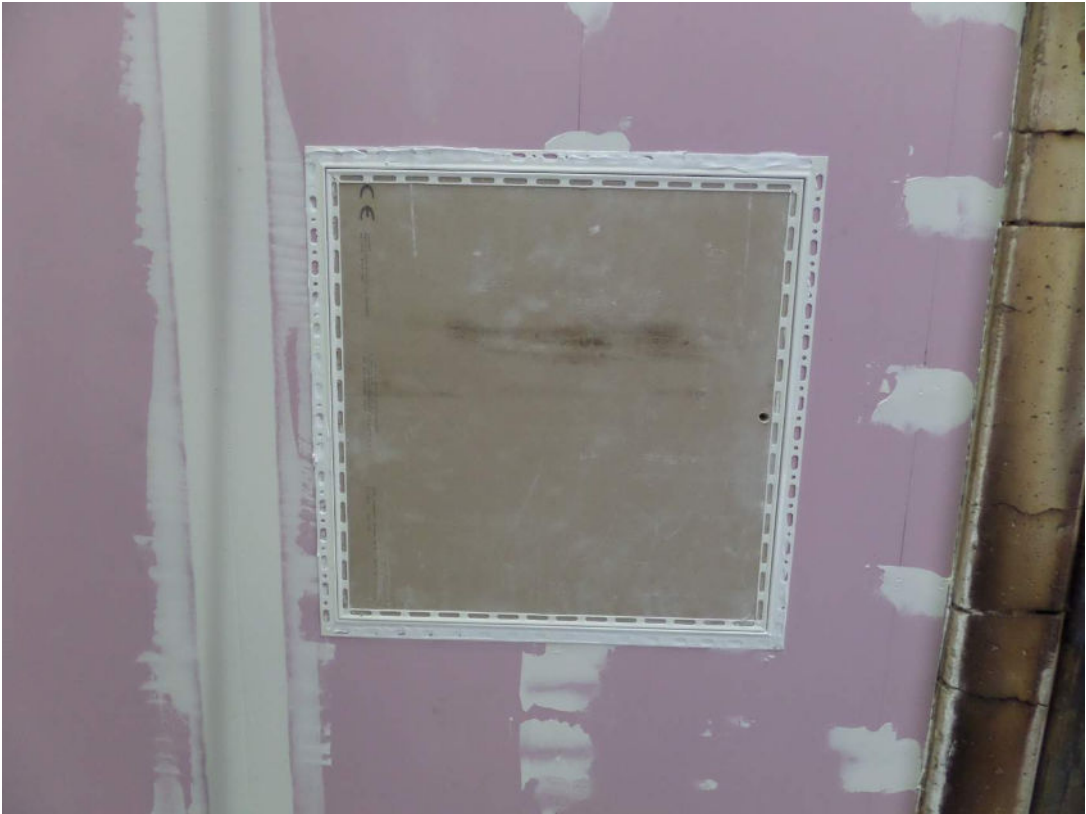
Exposed face prior to testing

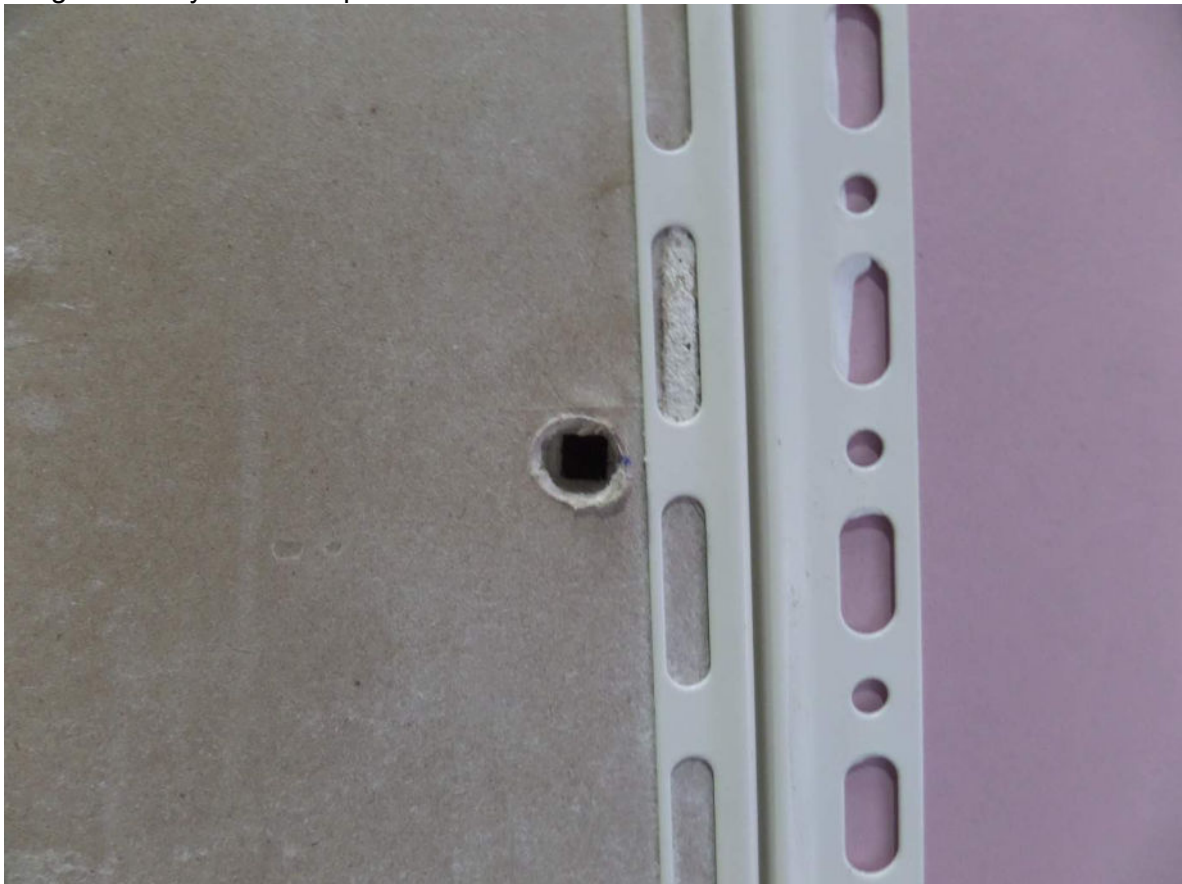
Budget lock key hole on exposed face

The loft access hatch was hinged on a rapid fit hinge with 2 No. pivot points enclosed within the reinforcement channel, with an engaged budget type latch centrally fitted on the opposite edge, and hung opening in towards the furnace.

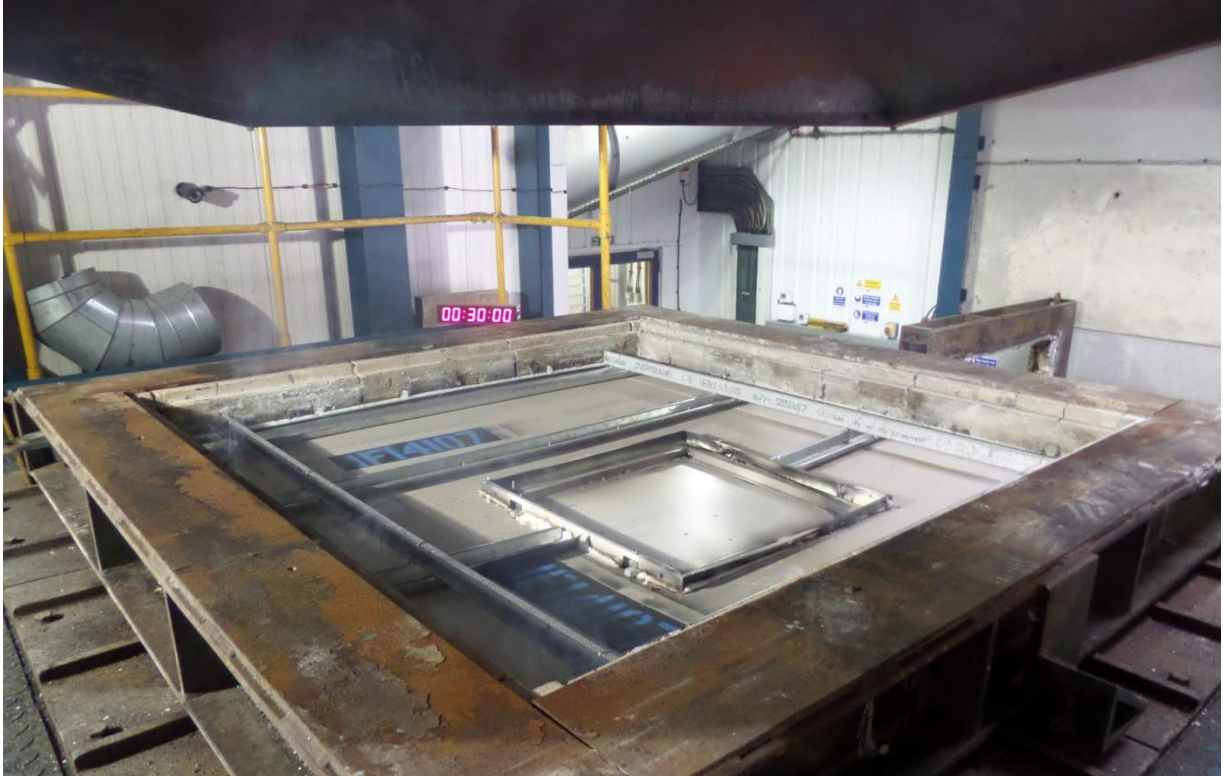
At 30 minutes

25.10	There is further discolouration to the edge of the leaf.
32.30	The top closing corner of the leaf has deflected into the furnace by approximately 7-10mm.

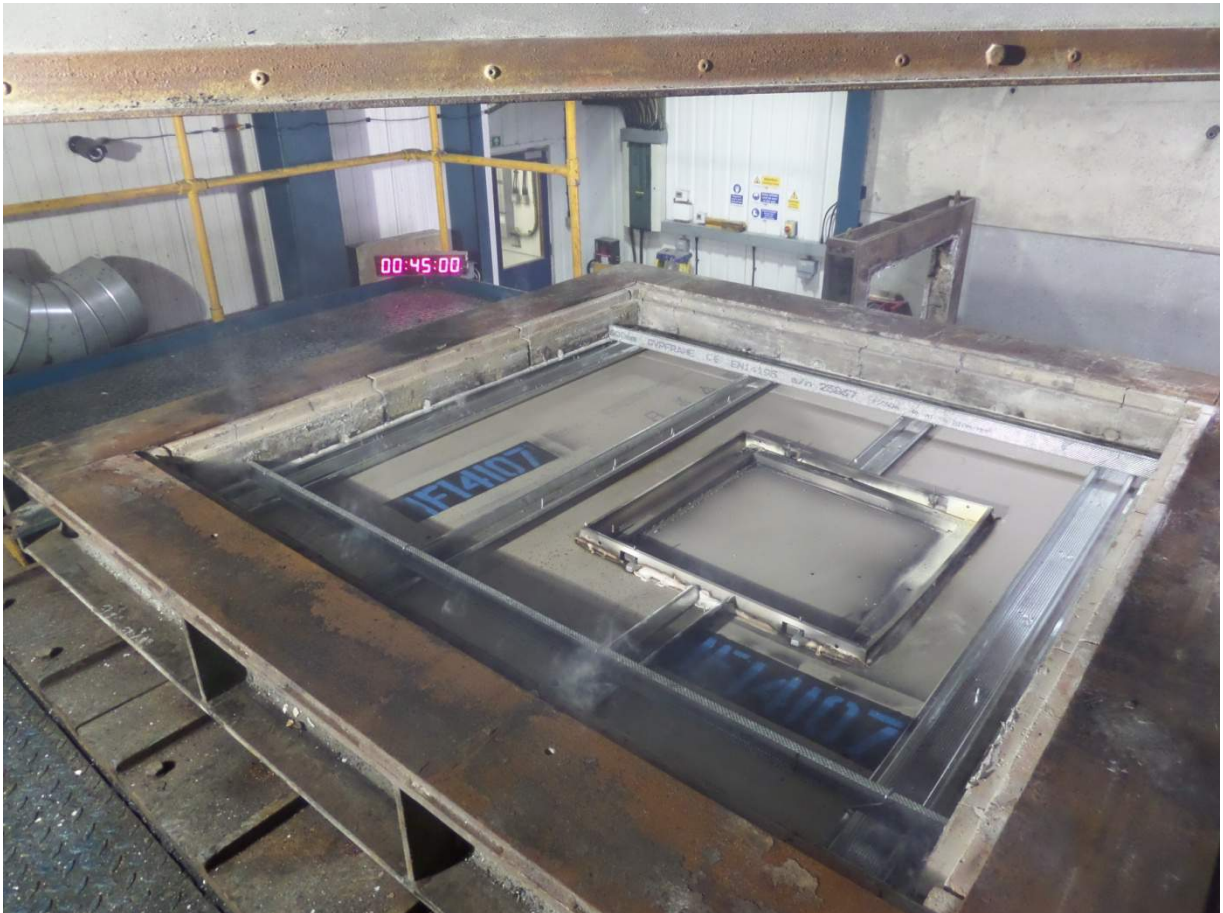
At 45 minutes

43.30	There is discoloration over the entire face of the leaf.
52.00	Exposed face, the first layer of the plasterboard is starting to fall away from the ceiling membrane.

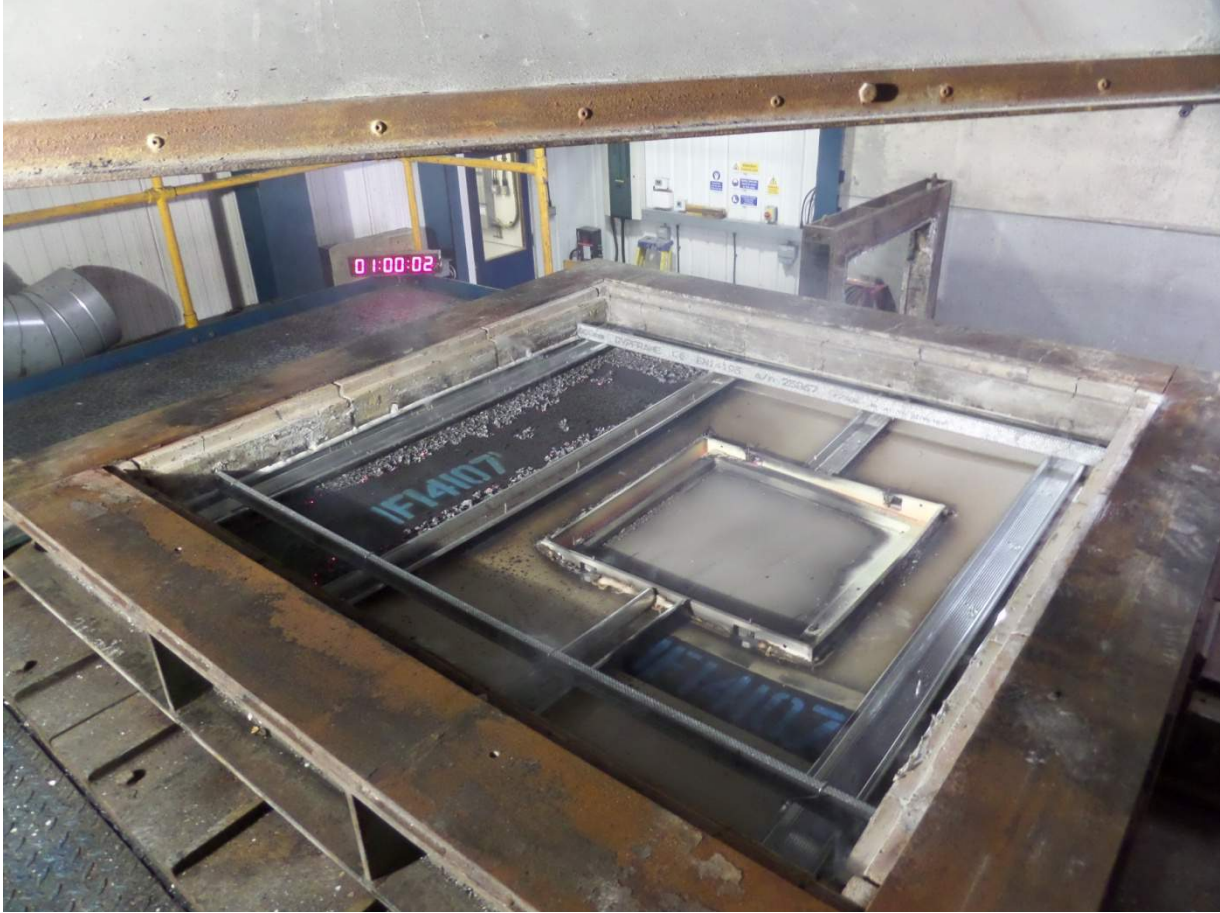
After 60 minutes

55.00	The top closing corner of the leaf has deflected into the furnace by approximately 10-15mm.
56.00	There is discolouration to the ceiling at the perimeter of the frame.

63.00	The specimen is starting to fall through the ceiling at the hanging edge.
64.00	Test terminated.

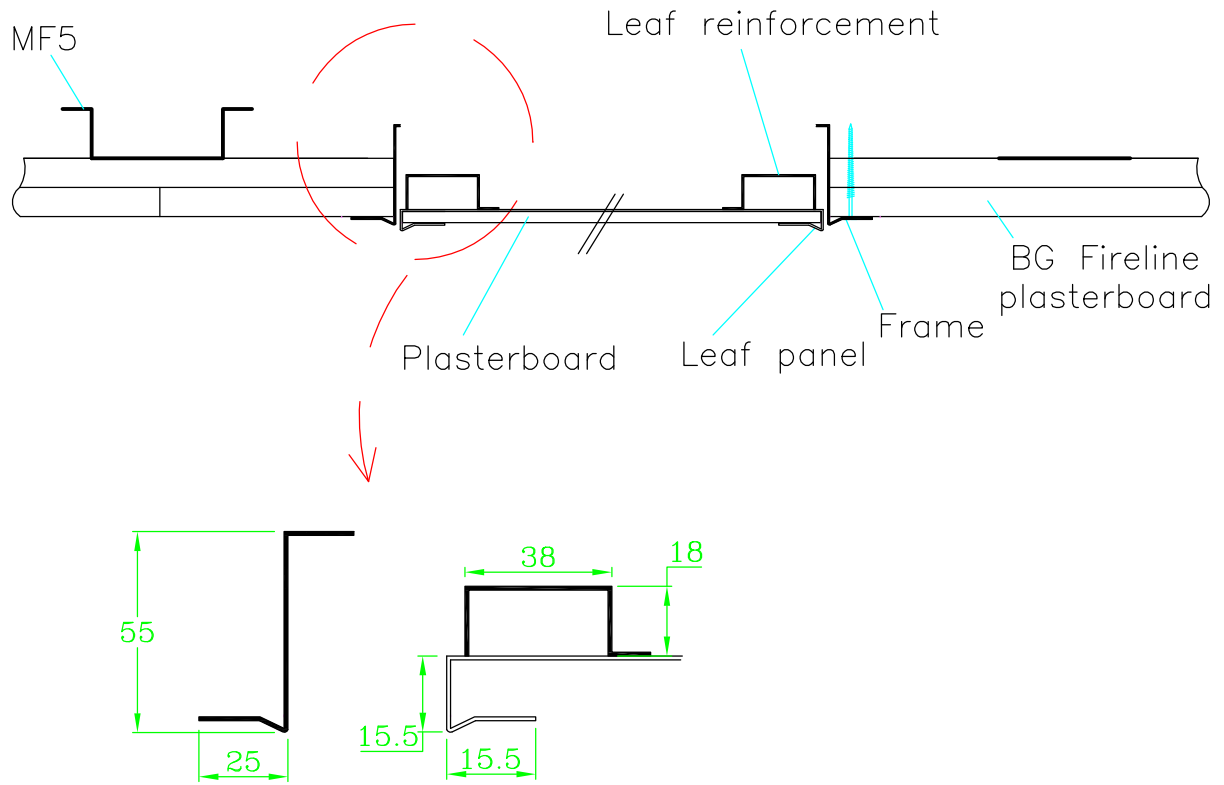
Section A – A

Cross section of access panel
 (All measurements in mm)

The hatch panel (Plasterboard Faced Flipfix) measured 588mm long x 588mm wide x 59mm thick overall. The hatch panel frame comprised powder coated 0.9mm thick perforated profiled Zintec steel enclosing a 15mm thick plasterboard core. The frame comprised 0.9mm thick powder coated perforated Zintec steel 600mm long x 600mm wide x 59mm high including a 25mm wide integral architrave. The frame was fixed into the aperture with 4 No. 'flip clip' adjustable fixings. 2 No fixings were present on 2 edges, 130mm from corners on adjacent sides.

The hatch panel comprised a tray profile 15.5mm thick, welded at the corners.
